Subject Fish and Fish Habitat Technical Memorandum

Project Name Eagle Mountain – Woodfibre Gas Pipeline Project (EGP Project)

Date August 4, 2022

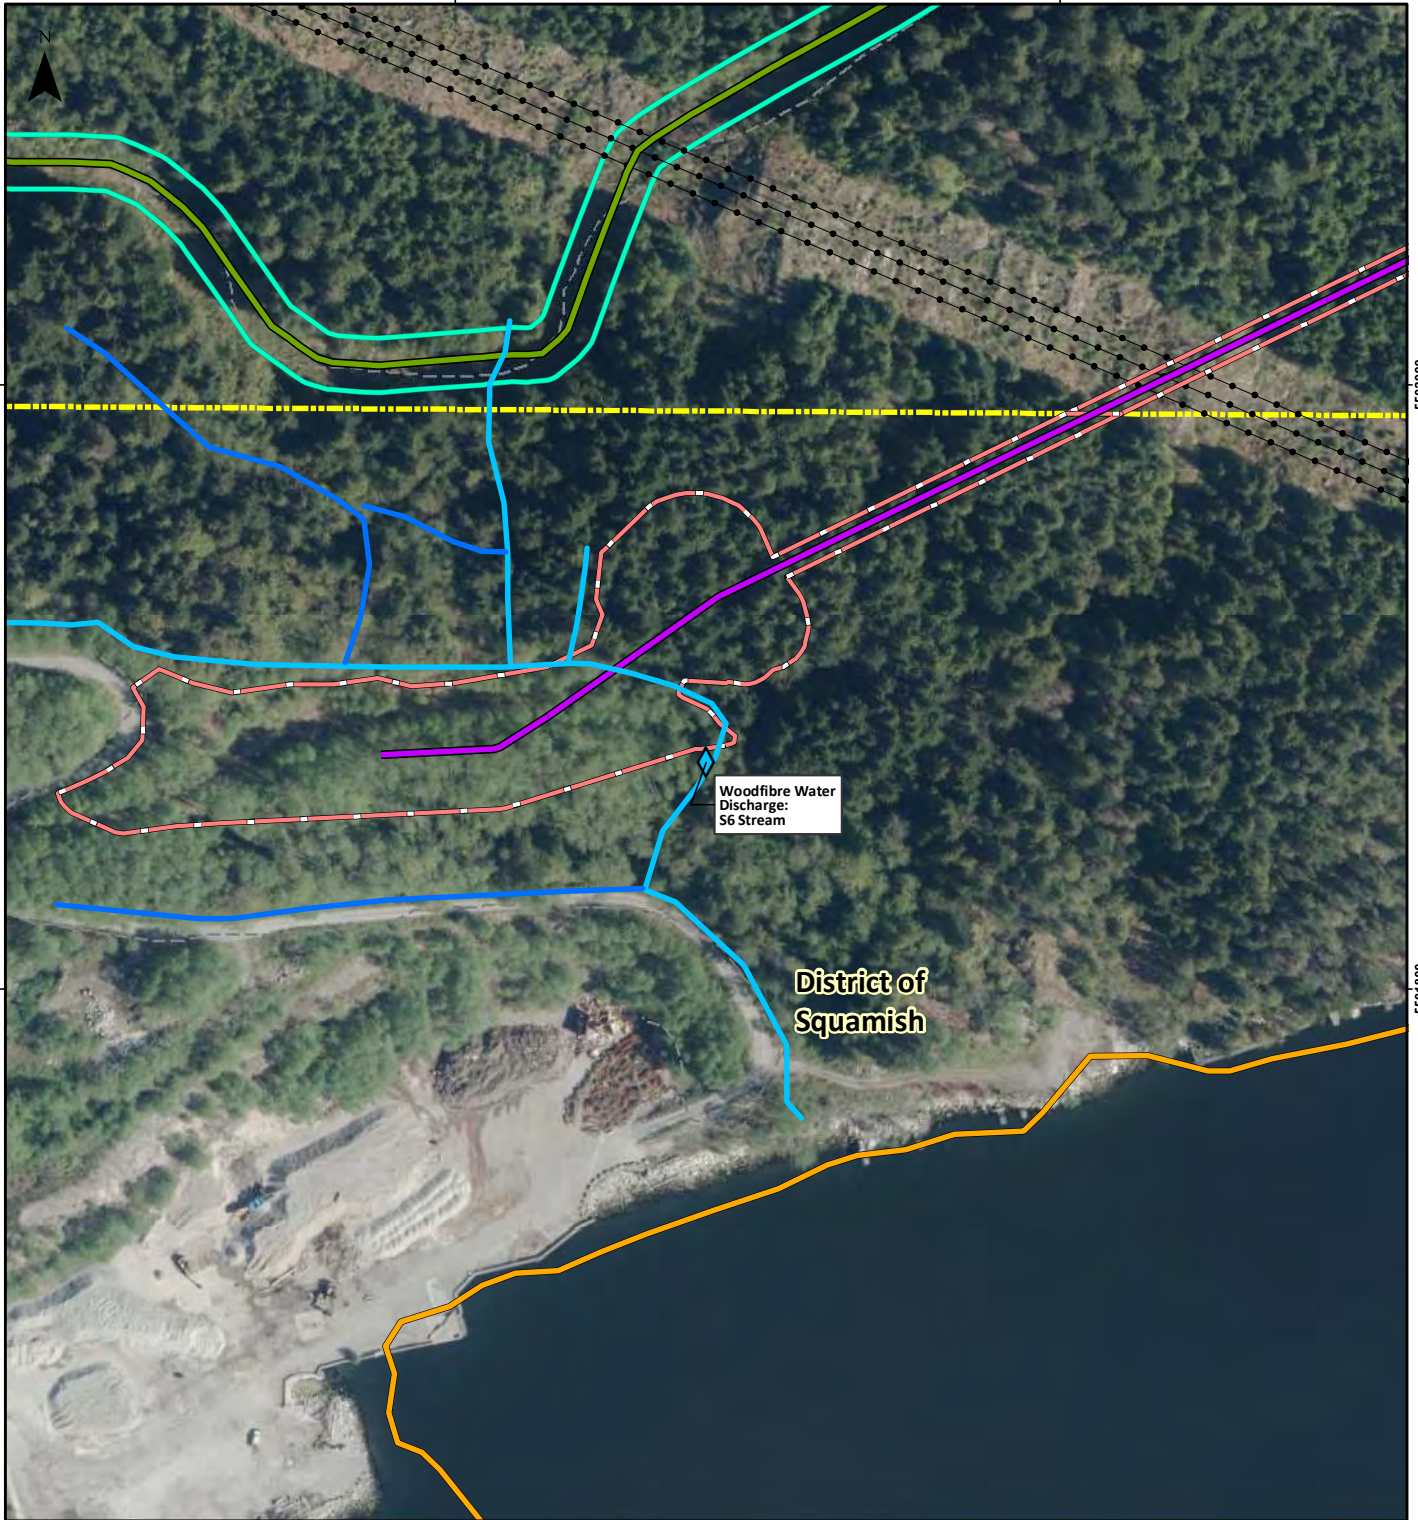
FIGURE 1
WATER DISCHARGE - WOODFIBRE SITE
EAGLE MOUNTAIN-WOODFIBRE GAS PIPELINE PROJECT

Woodfibre Water Discharge: S6 Stream

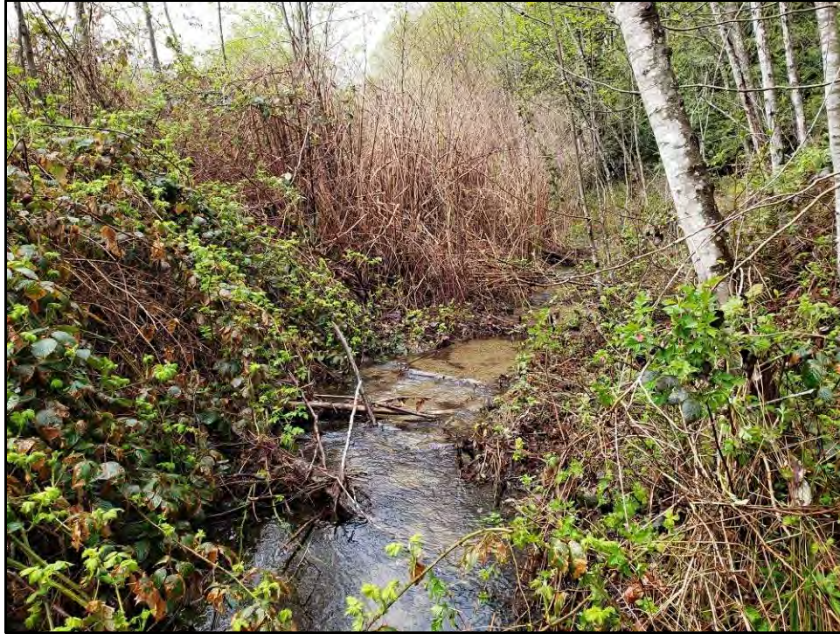
Photo 1. View upstream of Unnamed Tributary to Howe Sound along low gradient bench adjacent to the portal site (April 17, 2019).

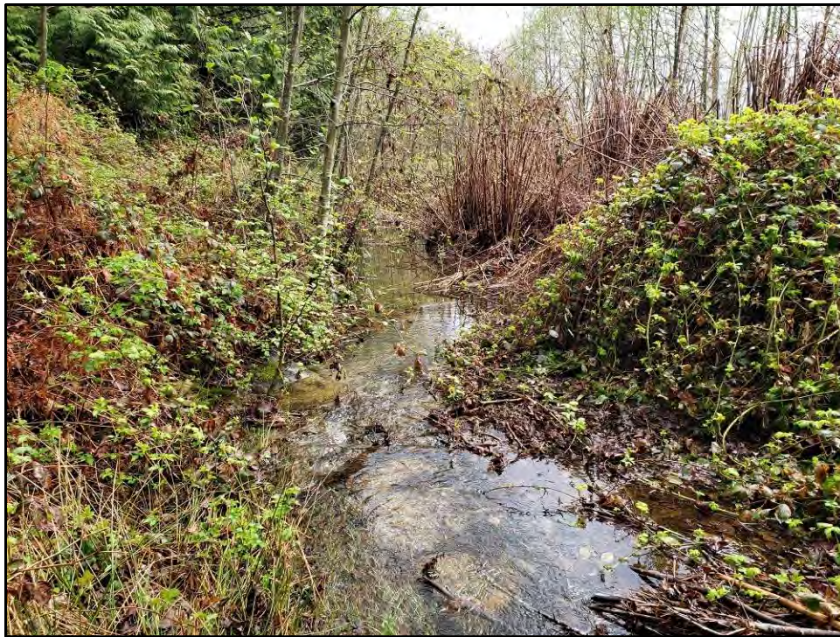
Photo 2. View downstream of Unnamed Tributary to Howe Sound along low gradient bench adjacent to the portal site (April 17, 2019).

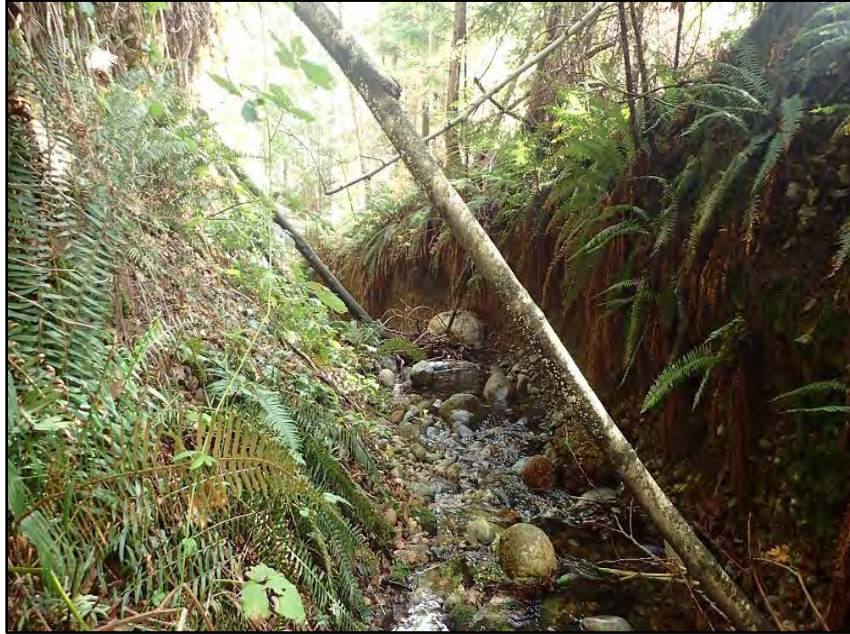
The channel width varied between 1 and 3 m wide along the assessed reach. Depths were shallow and generally less than 0.2 m. The substrate was variable, consisting mostly of fines with lesser amounts of gravels along the lower gradient bench. Coarser cobble and boulder substrates were present along steeper gradient sections of the stream. Bank structure was also variable with areas of valley or road fill confinement, presenting steep and sometimes unstable banks (upstream of the discharge location, Photos 3 and 4).

Photo 3. View downstream of bank/fill erosion, approximately 40 m upstream of the proposed discharge. (October 4, 2019).

The field survey identified that the stream banks were partially eroded, indicating that the current discharge is likely exceeding the stream capacity. Mitigation is in development to ensure there will be no risk to fish or fish habitat. To avoid harm to fish or fish habitat the discharge into Howe Sound should also meet the BC Water Quality Guidelines, and implementation plans should be reviewed by a hydrologist to determine how to meet the guidelines (Province of BC 2021d).

The current stream channel morphology has not been adequate for the natural flow regime as there was evidence of erosion and unstable banks, resulting in a higher risk for sediment mobilization during instream work. The stream would likely require bed and bank stabilization, armouring such as rip rap, and sediment fencing to handle an increase in discharge, and to manage the risk of exceeding the BC Water Quality Guidelines for discharge into Howe Sound. Another option to reduce the risk of sedimentation associated with the unnamed tributary to Howe Sound would be to lengthen the discharge pipe, and discharge directly into Howe Sound or at a lower point on the tributary.

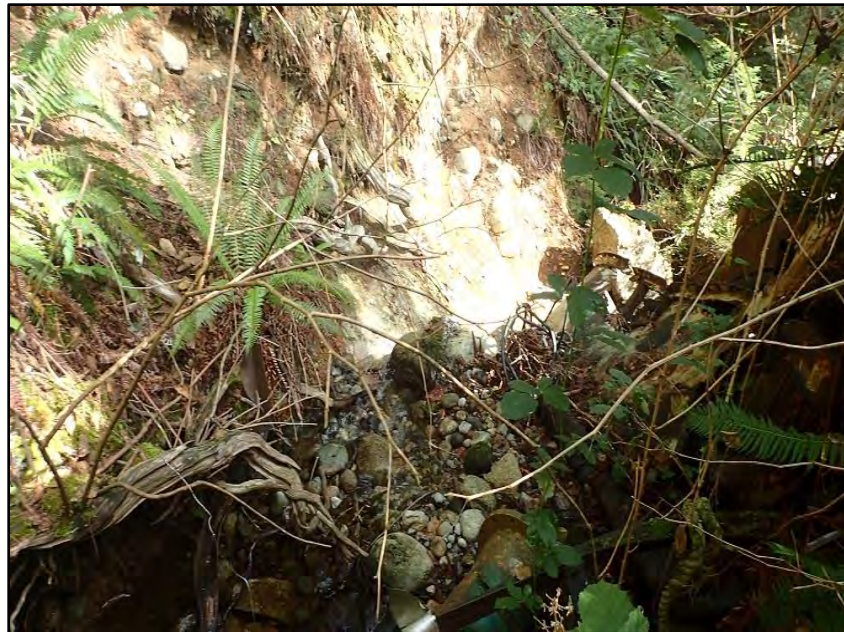
Photo 4 View downstream at bend approximately 30 m upstream of the proposed discharge location, showing instability and erosion on north slope. (October 4, 2019).

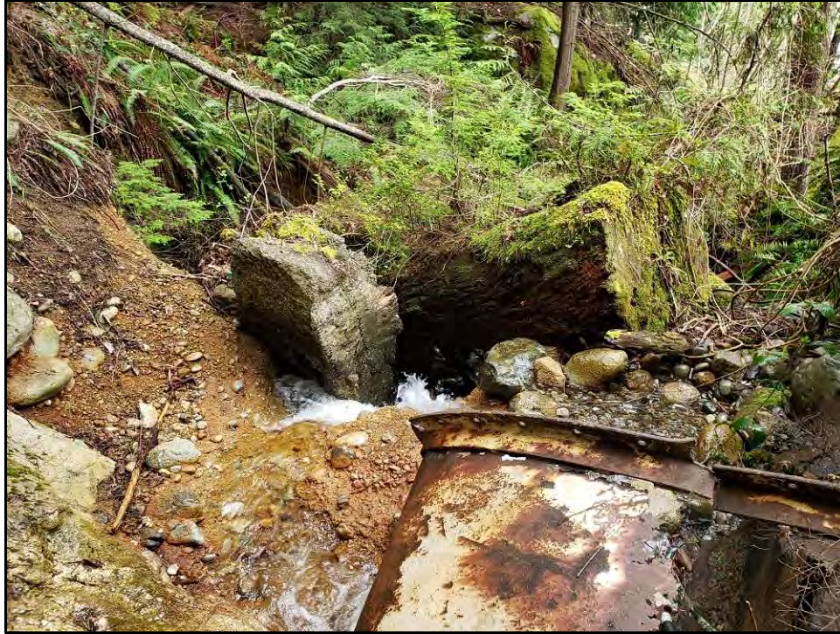
Photo 5. View downstream approximately 20 m upstream of the proposed discharge location, showing bank instability and metal debris/boulders in the watercourse. (April 17, 2019).

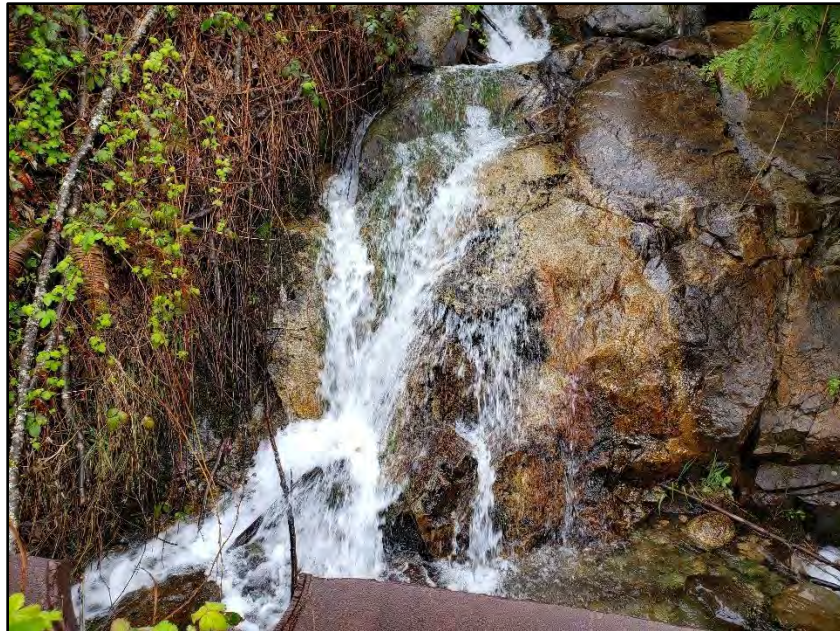
There were several barriers to fish passage along the stream including gradients exceeding 30% and a 3 to 4 m waterfall (Photo 6). Drops of 0.6 to 1.2m without pools and a hanging culvert impaired fish access from the intertidal zone (Photo 10). A lack of perennial habitat potential was noted above the barriers along the lower gradient bench with no deep pools and shallow seasonal conditions. Due to barriers to fish passage and seasonal lack of flow and depth for perennial suitability, the watercourse is classified as non-fish bearing. The intertidal zone of Howe Sound is expected to be the closest fish habitat to the discharge site, providing habitat for a variety of marine fish and invertebrate species.

Photo 6. View upstream of waterfall (3 to 4 m barrier to fish passage) approximately 100 m upstream of Howe Sound (April 17, 2019).

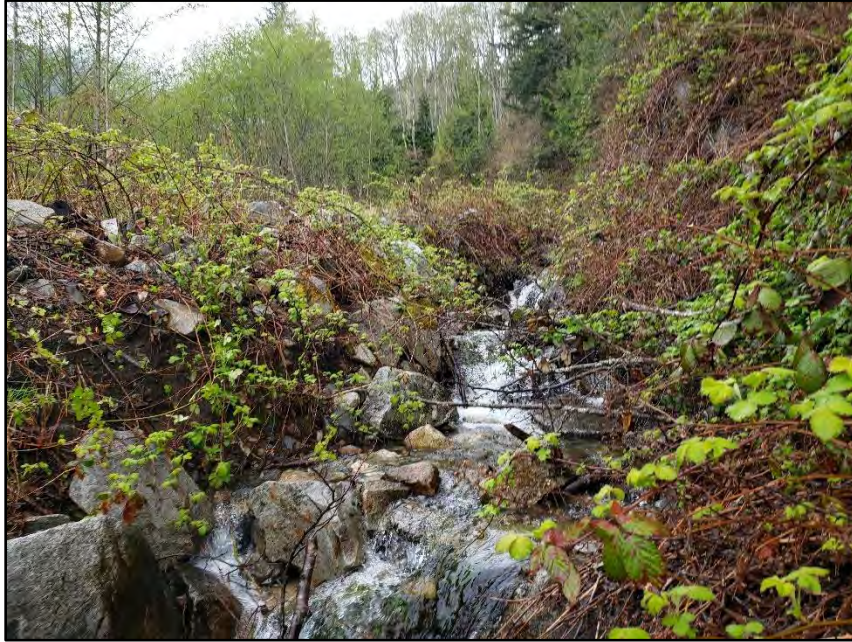
Photo 7. View upstream of ditch from downstream of the discharge location, in the lower ditch reach before Howe Sound. (April 17, 2019).

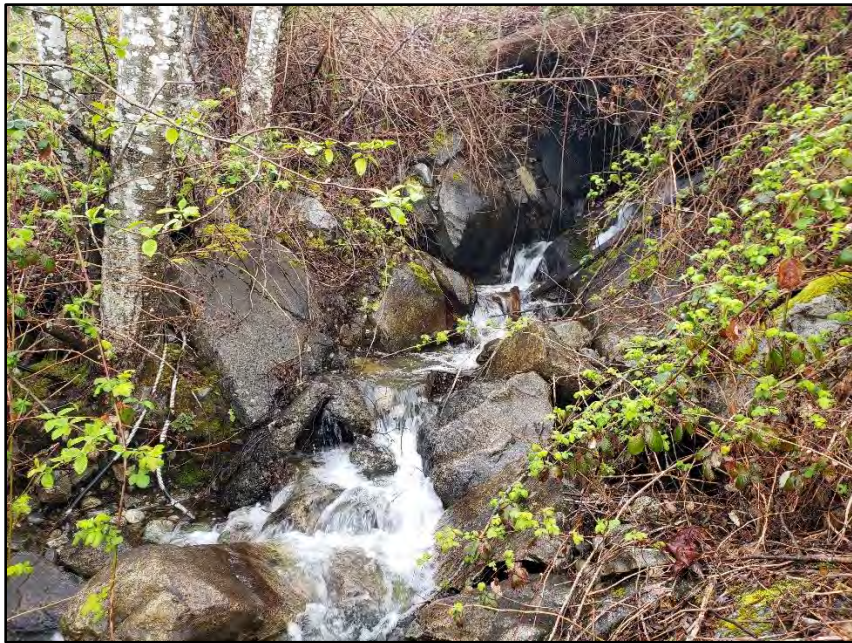
Photo 8. View upstream 15 m upstream Howe Sound interface showing 33% slope (fish access barriers). (April 17, 2019).

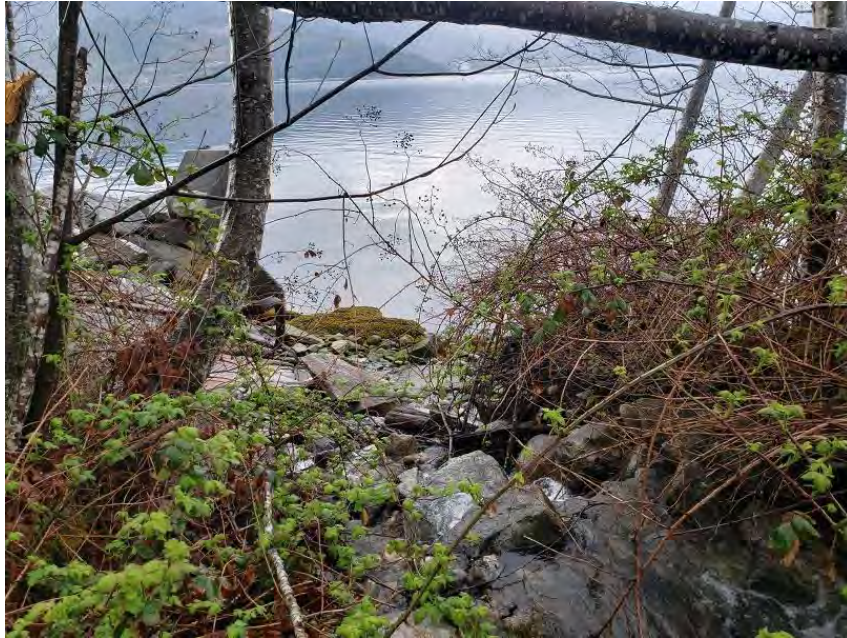
Photo 9. View downstream towards the intertidal zone and Howe Sound. (April 17, 2019).
